AMANZIMTOTI RAILWAY: EMBANKMENT RECONSTRUCTION AND REHABILITATION USING A SPECIALIST GEOSYNTHETIC SOLUTION

P.E. Lombard¹, BSc Geology, Kaytech

S. Naidoo², BTech Civil Engineering, Madan Singh and Associates cc

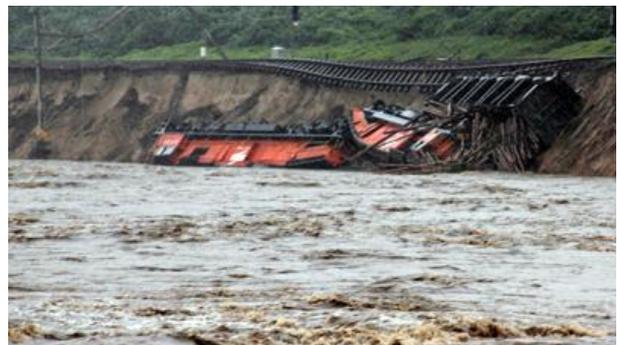
Figure 1: Derailment of three of the electric units [1]

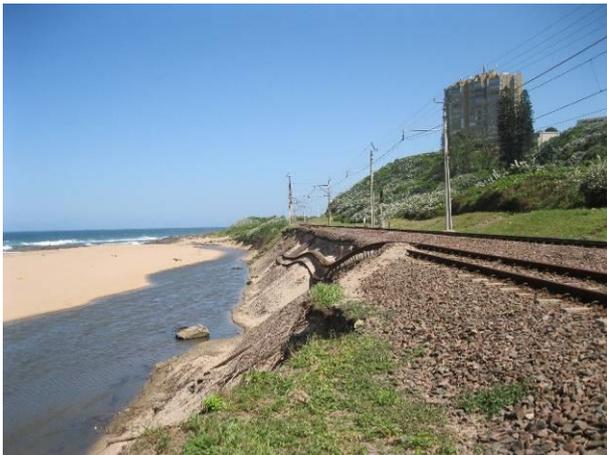
The site is located in Amanzimtoti in Kwazulu-Natal adjacent to the Amanzimtoti River. A complete failure of approximately 350m of the railway embankment carrying the South Bound rail line occurred on Thursday 11th December 2012 after torrential rains and flooding of the Amanzimtoti River resulted in the derailment of three of Transnet's electric units and their collapse into the river at the foot of the embankment. This resulted in a change of the scope of the works from the original submission, which involved embankment protection. This project was at tender stage before the unforeseen collapse occurred.

Figure 2: Collapsed Rail, South Bound

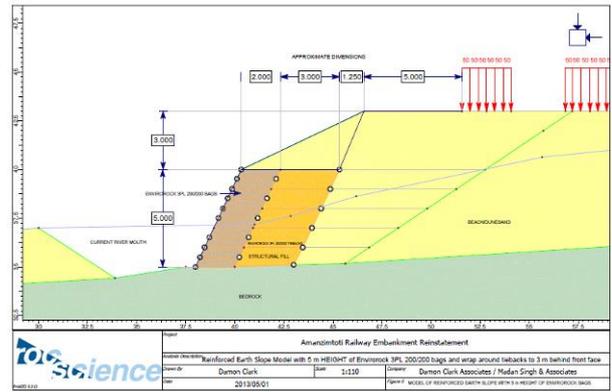
Option 4.1: A single row of high strength (200 x 200 kN/m) multi-laminate reinforced GSCs wrapped with a high strength (200 x 200 kN/m) multi-laminate reinforcement geotextile tied 4m into the embankment up to a height of 5m, thereafter sloped 6.25m back towards the top of the embankment. This option although cost effective showed a risk of losing back-fill material over the top of the GSCs.

Figure 3: Option 4.1: 200 x 200kN GSC with reinforced tieback into embankment fill to 5m high

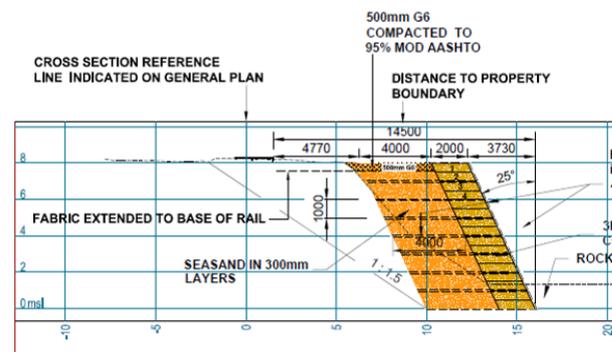
Option 4.2: A single row of high strength (200 x 200 kN/m) multi-laminate reinforced GSCs reinforced with a high strength (200 x 200 kN/m) multi-laminate reinforcement geotextile tied 4m into the embankment up to a height of 8m. Sand was sourced on site and it was decided that this sand was to be used as backfill due to its free draining properties (initially G7).

Figure 4: Option 4.2: 200 x 200kN GSC with reinforced tieback into embankment fill to 8m high

Ultimately Option 4.2 was approved as the most cost effective, environmentally friendly, aesthetically pleasing and structurally stable choice.

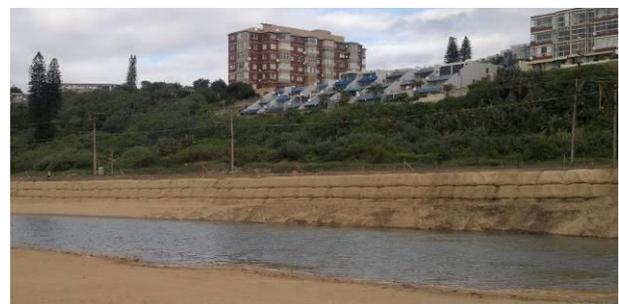
Figure 6: Completed embankment protection - South Bound

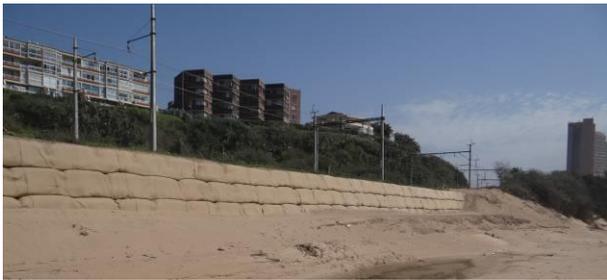
Figure 7 : Completed embankment protection - North Bound
