HEAVY HAUL RAIL PERFORMANCE AT TRANSNET

J Duvel, Pr.Eng CPEng, Principal Track Engineer, Transnet Freight Rail

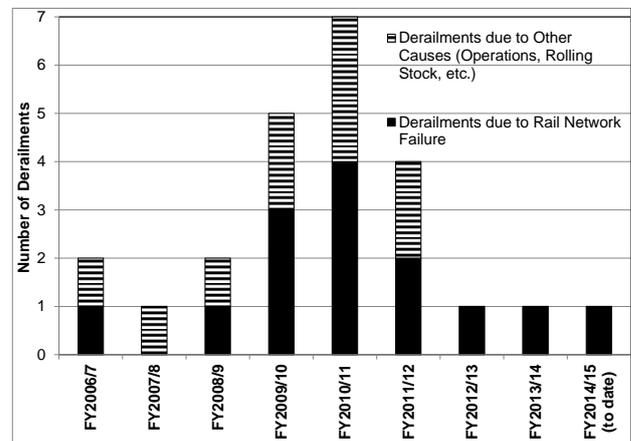
Figure 1. Derailment History

The ORELINE derailment history since FY2006/7 is shown in Figure 1. This reveals a strong upward trend in all derailments up to FY2010/11 and then a dramatic improvement since. Almost 60% of all derailments over the past 9 years have been due to Rail Network failure. The overwhelming majority of derailments due to Rail Network failure are due to rail breaks and thus the contribution of rail breaks to all derailments is 54%.

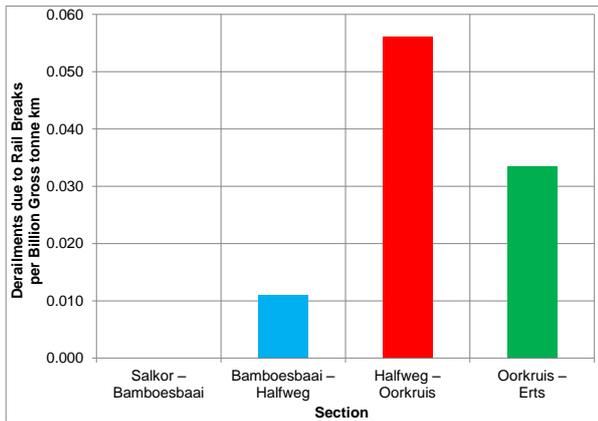
Figure 2. Density of Derailments due to Rail Break per Section

An assessment of the derailments due to Rail Network failure per section reveals a significantly higher derailment density for the sections north of Halfweg (see Figure 2). The density of derailments for the entire line is 0.026 Derailments due to Rail Breaks per Billion Gross tonne km, contrasting starkly with the COALLINE experience over the past 6 years of only 0.006. Furthermore, when benchmarked with the Class 1 railways, the ORELINE is at a considerably higher rail break caused derailment density.

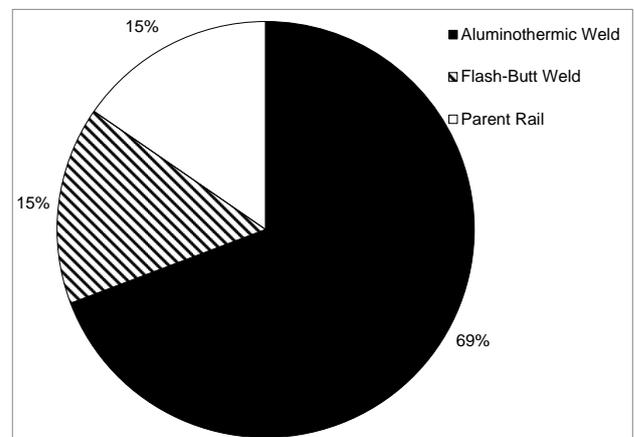
Figure 3. Distribution of Position of Rail Breaks causing Derailments

A deeper analysis of the position of rail breaks leading to derailments on the ORELINE reveals that over two-thirds of rail break related derailments are due to failure of aluminothermic “Thermit” welds, shown in Figure 3. The distribution differs somewhat with that of rail breaks, with the contribution of aluminothermic welds to derailments being greater than the contribution of aluminothermic welds to rail breaks, indicating that aluminothermic welds have a greater propensity for derailment (compared to flash-butt welds and parent rail). Furthermore, ultrasonic detectability of defects in aluminothermic welds is very low. Therefore, particular effort is required to improve the management of aluminothermic welds, as this is the most significant derailment risk.

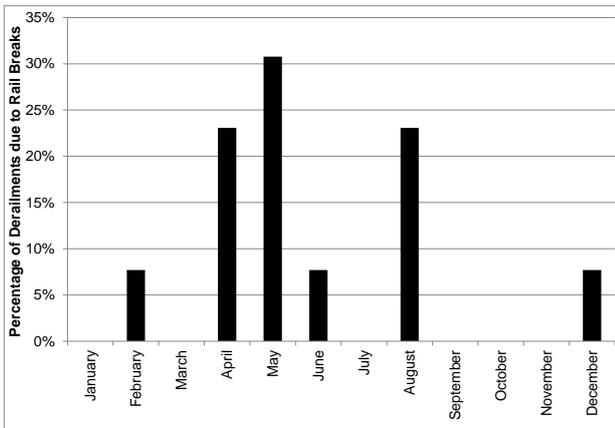
Figure 4. Seasonal Variations in Derailments due to Rail Breaks

A significant 85% of derailments due to rail breaks occur in the winter period from April to August (see Figure 4), not surprising since this is the period of higher incidence of rail breaks. The “cold snap” months of April and May are the first high season period for derailments due to rail breaks, accounting for 55%. August is the next high season due to very low temperatures, accounting for almost a quarter of derailments due to rail breaks. Two derailments have occurred in summer (both on welds), demonstrating that if the vertical load (and therefore bending stress) is sufficiently high and the rail foot defect is large enough, the combined effect can be catastrophic even in the absence of tensile longitudinal stress. This further demonstrates the need to tightly control rail longitudinal stresses.

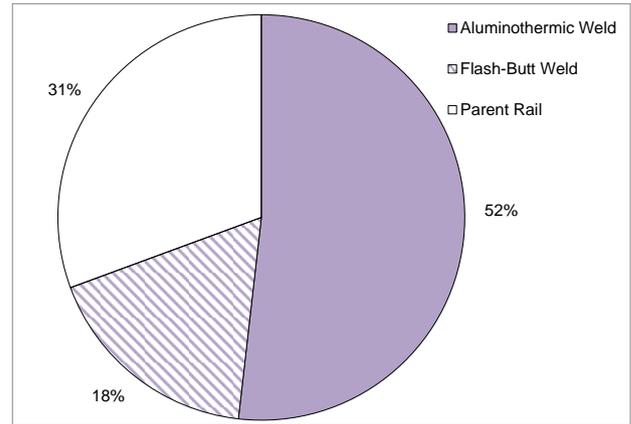
Figure 5. Rail Breaks by Position

Since April 2006, a total of 222 rail breaks have been reported for the mainline. Rail breaks can be divided into those attributable to rail quality and fatigue of parent rail, and those related to the welding of rails [6], shown in Figure 5. There has been a sudden increase in rail breaks towards FY2009/10, and a dramatic plunge in FY2012/13 (see Figure 6) – largely due to a significant reduction in aluminothermic weld failures. The trend mirrors to a large extent the trend in derailments over the same period and points to rail longitudinal stress being a key driver in the occurrence of rail breaks. Rail breaks related to welds account for 70% of all rail breaks. This value is higher than the experience of the COALLINE for the past 5 years of 59%, but considerably lower than the BHPBilliton Iron Ore Railway (BHPBIO) experience for the period 2001-2004 of 85% [7, 8]. Nonetheless, this highlights the importance of satisfactory welding being performed on an ongoing basis, specifically aluminothermic welding. The earlier flash-butt weld failures due to the spheroidite zone dipping and related “upward bending & grinding” project previously completed are presently not a feature, as the original Grade

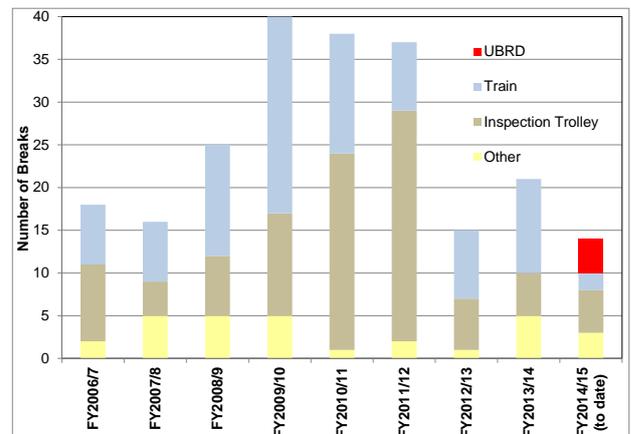
Figure 6. Rail Break Trends by Detection

On average, there has been a reasonably even split between breaks reported by train drivers and breaks detected by routine inspections done by the daily patrol trolleys or Track Inspector trolleys. Of significance is the contribution of the UBRD system which has successfully reported 4 breaks, i.e. almost a third of all breaks in FY2014/15 to date. It is therefore safety-critical to complete the roll-out of the program and ensure full availability of the system. The current availability of the system has been impacted by theft of solar panels, batteries and charging regulators.

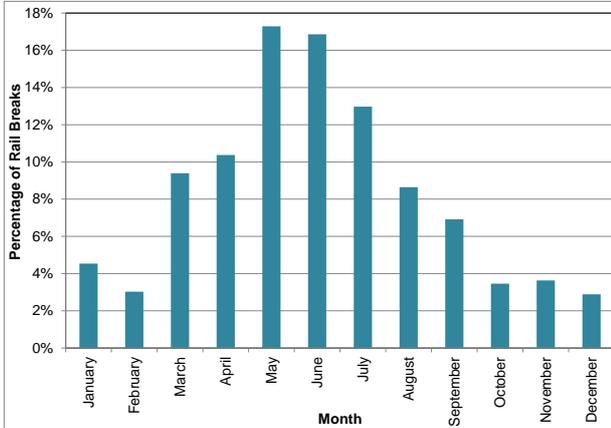
Figure 7. Seasonal Variations in Rail Breaks

An assessment of the incidence of rail breaks through the year shows that the months of May to July jointly contribute to almost half of all annual rail breaks (see Figure 7). The peak month is May,

at the onset of the winter period, when daily minimum temperatures plummet significantly. The annual temperature fluctuation is considerably deeper for the interior, compared to the coastal areas. This naturally results in the need for a tighter destressing range (A-range) for the interior sections, compared to the Saldanha – Bamboesbaai section.

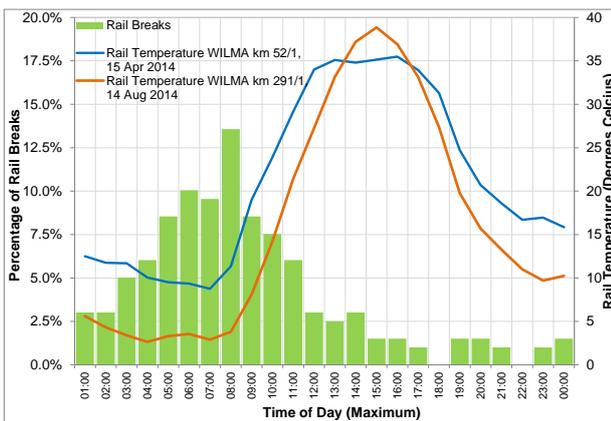
Figure 8. Daily Variations in Rail Breaks

The time of day that rail breaks occur naturally varies considerably through the day as a function of rail temperature (see Figure 8). The incidence of breaks increases steadily from mid-night, peaks during the prime time hours of 07:00 to 08:00, and thereafter drops rapidly towards noon and is then reasonably stable until mid-night. 75% of breaks occur from 02:00 to 11:00. During the danger period from April to August (i.e. when the probability of rail breaks and the probability of derailments due to rail breaks are both significantly high), the coldest time of the day is at around 08:00 and rail temperatures rise rapidly from this point onwards.

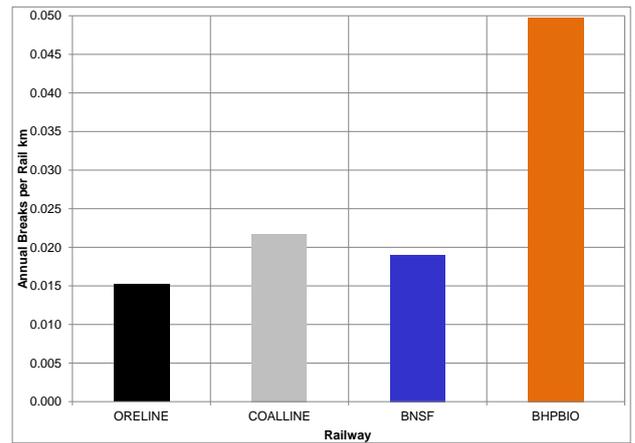
Figure 9. Annual Breaks per Rail km and Benchmarks

The average density of breaks occurring per year, normalised by line length, is 0.015 Annual Breaks per Rail km. This is an internationally recognised metric [9] and the ORELINE performance is commensurate with the recent experience since 2009 on the COALLINE and the only available

Class 1 benchmark, BNSF (2000-2003) [10, 11]. Furthermore, the ORELINE performance is significantly better than the performance of BHPBIO for the period 2001-2004. See Figure 9. The higher break densities for the interior sections (demonstrated in Figure 10) are not surprising, ~*inter alia*~ due to the following:

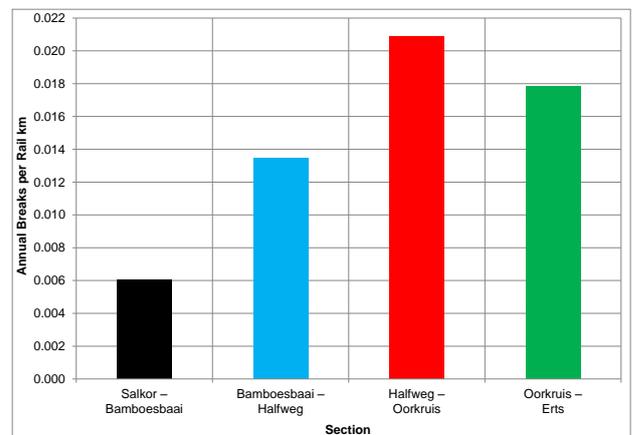
Figure 10. Annual Breaks per Rail km by Section

- Higher failure rate of welds, particularly in the Halfweg – Oorkruis section;
- Higher rail tensile longitudinal stresses due to deeper temperature fluctuation below the destressing range;
- A higher proportion of steeper gradients in the interior sections, i.e. gradients 1 in 250 and steeper. Traction loading, braking forces and related rail movement increases rail longitudinal stress. Furthermore, rail surface damage influences rail internal defect formation. Altitude of the line is shown in Figure 11; and
- A higher proportion of track of 1500m radius and sharper curvature in the interior sections. These areas are subject to more eccentric loading, higher lateral loads and increased Rolling-Contact Fatigue (RCF).

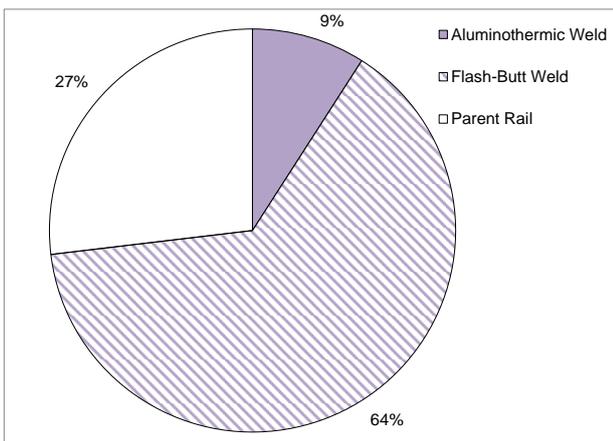
Figure 12. UMC Rail Defects by Position

A total of 2253 classifiable Ultrasonic Measuring Car (UMC) rail defects were detected since April 2006. The distribution of rail defects according to position reveals a significant problem (see Figure 12): The distribution contrasts starkly with what is experienced for rail breaks and proves that ultrasonic detectability of defects in aluminothermic welds is significantly lower than that of flash-butt welds.

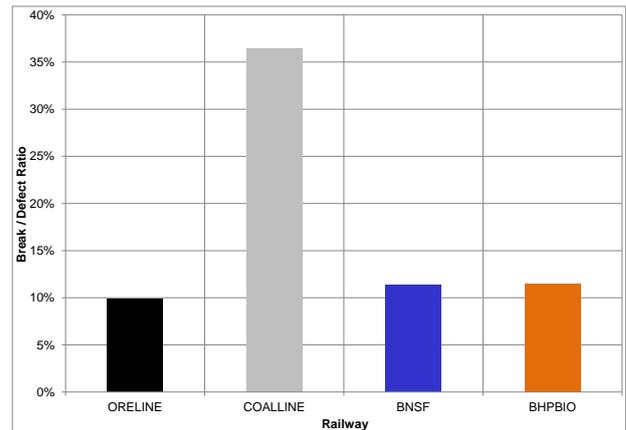
Figure 13. Break / Defect Ratio and Benchmarks

Now, it is imperative to sufficiently detect failures whilst these are still only in the form of defects, prior to maturing into breaks. The successful management of rail breaks includes frequent rail testing in order to detect defects prior to ultimate failure and it is important to ensure acceptable levels of safety, whilst avoiding overly conservative rail replacements [12]. The Break / Defect Ratio is an internationally recognised metric [9] to assess the effectiveness rail management strategies. It infers that a sufficient base of prior-detected defects is in fact necessary to enable the effective control of rail breaks. One requires a reasonably-shaped “incident pyramid”, with the breaks being an acceptable fraction of the defects. The Break / Defect Ratio of 10% for the ORELINE is commensurate with the BNSF (2000-2003) and BHPBIO (2001-2004) benchmarks. The

COALLINE shows significantly poorer performance compared to all railways. See Figure 13.

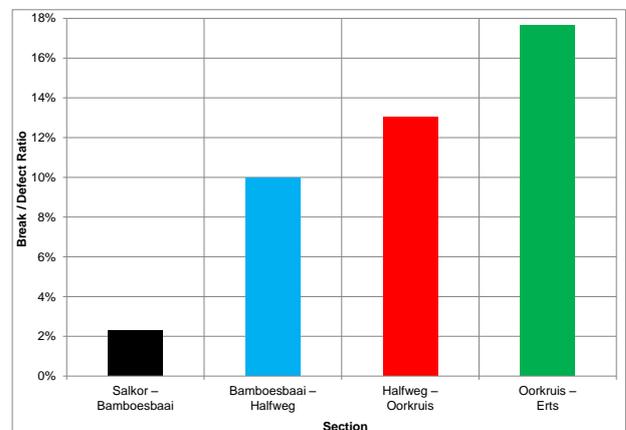
Figure 14. Break / Defect Ratio by Section

As demonstrated in Figure 14, the interior (the Oorkruis – Erts section in particular) is performing considerably poorer than the remaining lines. The possible factors contributing to the higher Break / Defect Ratio on this section could include *~inter alia~* :

- An inadequate base of prior-detected UMC defects to cover the breaks, either due to: A significant proportion of defects in the foot of the rail avoid the scope of conventional ultrasonic rail testing. (It has been proven above that ultrasonic detectability of defects in aluminothermic welds is particularly low compared to that of flash-butt welds and the interior has a higher density of weld failures.); Poor rail surface condition is contributing to defects “hiding” from ultrasonic detection; Speed of ultrasonic testing is too high;
- Increased rail flexural stresses due to poor rail support, particularly at aluminothermic welds (i.e. track geometry and condition of sleepers, ballast and formation); and
- Increased rail longitudinal stresses due to inadequate measurement/ destressing.
