THE OLIFANTS RIVER BRIDGE - THE INHERENT PROBLEM

J.F. Bester, B.Eng (Hons.) Civil Engineering (Structures), Transnet Freight Rail

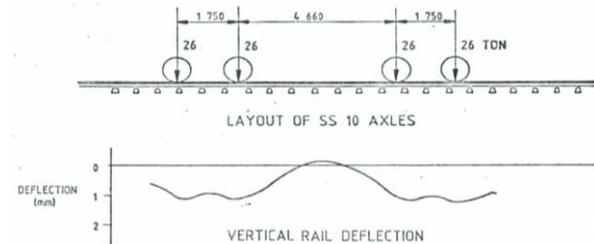
Figure 2. Reduction in downward normal force (taken from [4])

A simple analysis of vertical reactions under typical ore train loading of 1982 indicated a reduction in the downward normal force on the sleepers under the wagons (see Figure 2). This also means that the friction between the ballast and the sleeper is

reduced. Various sources suggest that the top ballast contributes 30% to 60% of the lateral resistance of the track superstructure [4, 6, 7]. Thus the kick out most probably occurred under a wagon of the loaded train.

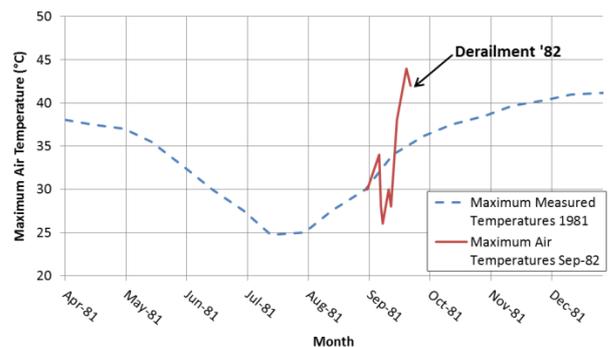
Figure 3. Maximum air temperatures (adapted from [4])

Various measurements were taken on the Olifants River Bridge between 1979 and 1981 by the Bridge Office and the then Track Development Office respectively. The air and rail temperatures as well as deck movement were extensively measured since 1979. Figure 3 shows the temperatures at the time of derailment, overlaid on the measurements conducted by the Bridge Office. The Track Development Office used vibrating wire strain gauges to measure the strains and the corresponding rail forces before the current monitoring system was installed in October 1982.

After the occurrence of the derailment, the measured data was used to approximate the expected track forces at the time of the derailment. This was found to have reached a peak value of about 3000 kN at the time of derailment, which is the combination of CWR (1100 kN) and deck forces (1900 kN) with the deck force accounting for about 60% of the total track force [4].

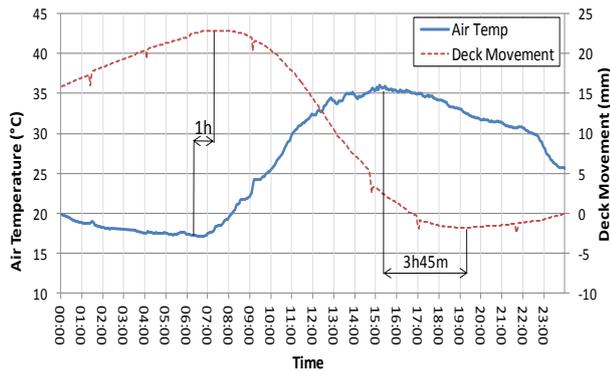
Figure 5. Delay in deck movement

The measured temperatures provide important information to improve the understanding of the bridge's performance. It shows how the increased air temperatures are followed by a rapidly increasing rail temperature as well as a delayed peak temperature for the concrete deck. The latter also causing a delayed deflection (see Figure 5) and the corresponding increase in rail force. The rate at which heat are transferred to the concrete is also influenced by factors like the wind, especially when it is blowing from the south-west (from the coast).

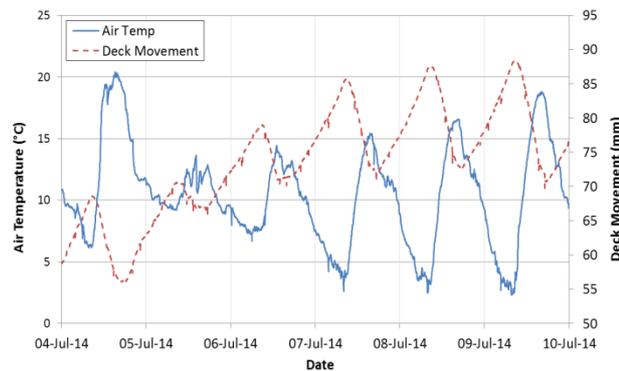
Figure 6. Influence of consecutive extremes on concrete deck movement

concrete deck has a delayed temperature peak and expansion, which is due to the low thermal conductivity of concrete. Concrete’s thermal conductivity is between 0.4 and 1.8 W/(m K) compared to steel’s value of 43 W/(m K) [10]. This property is a double edged sword. In the case of a single day of extreme weather the deck would not expand enough to induce excessive rail forces, but consecutive extremes cause deck movement that cannot recover in a day’s time. The effect of consecutive days can be seen in Figure 6.

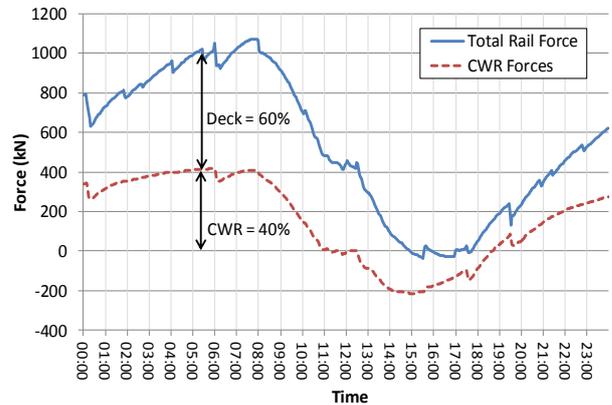
Figure 7. CWR and deck contribution to total force

The CWR forces for the rails on the bridge were calculated with an SFT of 32°C to which it was previously de-stressed. In Figure 7 it shows the CWR forces in a dotted line compared to the total rail force on the bridge. This clearly shows the forces that would be experienced on the open track compared to the combination of forces on the bridge.

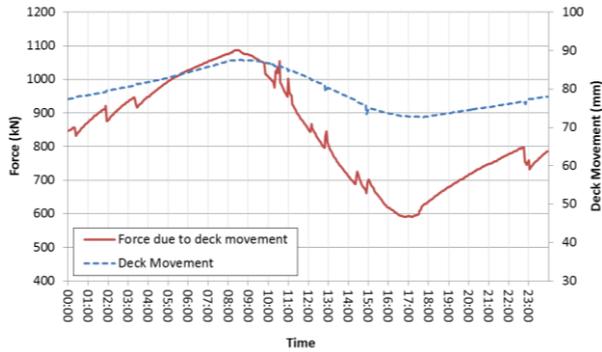
Figure 8. Force due to deck movement

This is a function of the weight of the track which will determine the normal force acting on the deck, while the condition of the ballast will most likely contribute to the value of the friction coefficient. The total movement of these expansion gaps in a year is up to 118 mm as recorded in 2014. Figure 8 shows the force induced by the bridge deck movement. This has been calculated by subtracting CWR forces from the measured rail forces. The force spikes also evident on the graphs are caused by train movement over the bridge. The actual forces caused by the bridge deck were approximated to be 24 kN per millimetre of deck movement as will also be shown in Section 5.1.

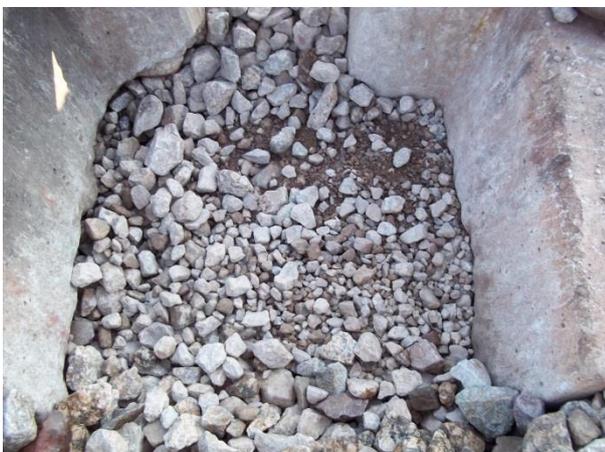
Figure 10. Ballast fouling at expansion gaps

Apart from the concentrated forces caused by the deck movement, this mechanism also causes deterioration of certain components of the track superstructure. The ballast in the vicinity of the expansion gaps break down faster than in other areas, due to the additional abrasive action caused by the daily and seasonal cyclic longitudinal movement. This leads to an increased rate of ballast fouling as shown in Figure 10.

During the shutdown a total of 50 winged PY sleepers and 80 m of ballast were replaced in the locations of the expansion gaps. This was required due to the deterioration of the track components. It was also important to ensure that the tamping of the track was done properly and correct the first time. Track geometry had to be within the A-standard and the sleepers were required to be within the height of the ballast retaining walls for additional lateral resistance as mentioned in Section 3.3.1.

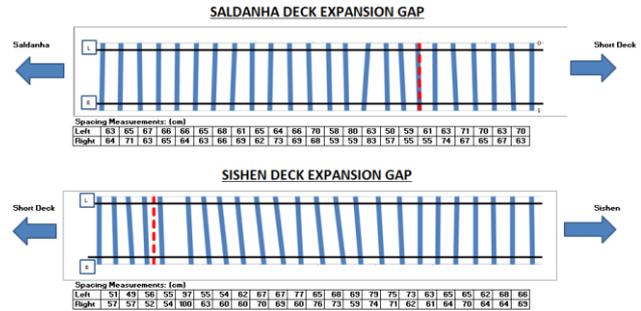
Figure 11. Sleeper movement due to forces

The breakdown of ballast also causes slacks to form at the expansion gaps, which requires it to be lifted out. The abrasive action between ballast and sleeper also causes the deterioration of the sleepers. The presence of the force concentrations is also evident in the movement of sleepers as can be seen in Figure 11, where the dotted red lines represent the location of the expansion gaps. These measurements were recorded in March 2013.
