A PROPOSED STANDARDISATION METHOD FOR THE INVESTIGATION OF BALLASTED TUNNEL FORMATIONS

O. Tywakadi, BSc Eng (Civil), Transnet (Track Technology)
J.K. Kae, BSc (Hons) Applied Science (Geotechnics), Transnet (Track Technology)

SUMMARY

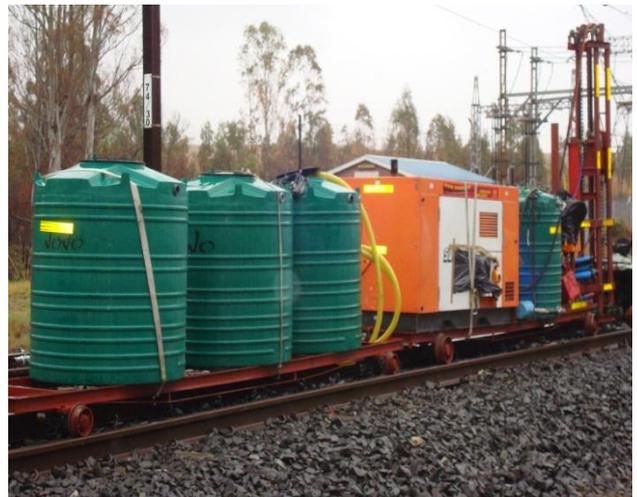
Figure 1: Tailor-made equipment for coring

having a core drilling procedure that will work within rock that has disintegrated and is under saturated conditions.

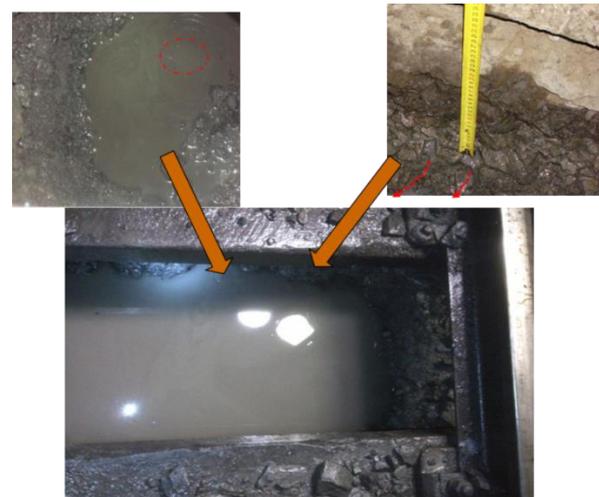
Figure 5: Seepage in test pits

Any seepage that may occur is initially observed during test pitting. Direction of water seepage should be thoroughly observed, as to whether the water is transmitting through the ballast layer or flowing vertically up in a form of spring action under artesian pressures. The first points to a problem upstream, while the latter indicates permeability of bedrock and a fracture zone at that particular chainage position. The time it takes to fill the test pit, as shown in **Figure 5**, can also be measured. The roof seepage had been restrained in the tunnels by installing rubber shields along the roof which divert water away from the track and into the surface runoff concrete channels.

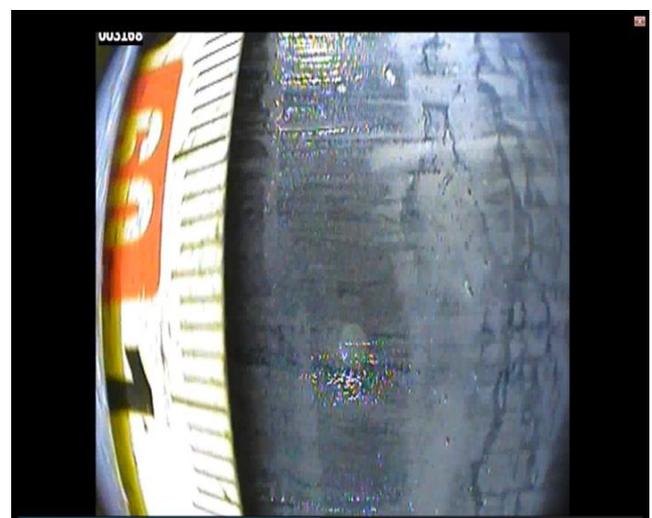
Figure 11: Typical camera inspection snapshot

A typical hole from Beacon Hill tunnel was inspected and the clip, as shown in **Figure 11** as snapshot, shows that the rock there has alternating bands of solid intact and fractured structure zones.
