HEAVY HAUL RAIL PERFORMANCE AT TRANSNET

J Duvel, Pr.Eng CPEng, Principal Track Engineer, Transnet Freight Rail

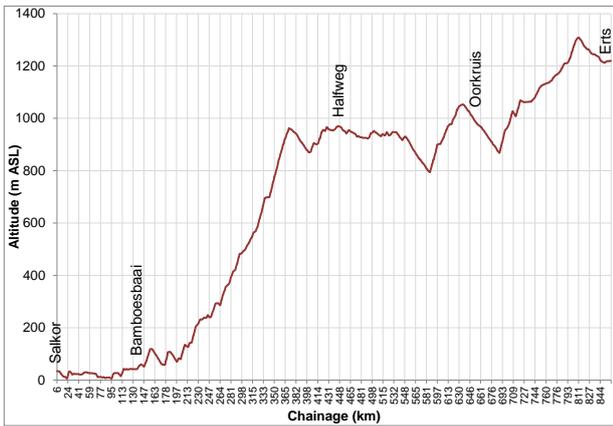
Figure 11. Altitude of the Line

- Higher failure rate of welds, particularly in the Halfweg – Oorkruis section;
- Higher rail tensile longitudinal stresses due to deeper temperature fluctuation below the destressing range;
- A higher proportion of steeper gradients in the interior sections, i.e. gradients 1 in 250 and steeper. Traction loading, braking forces and related rail movement increases rail longitudinal stress. Furthermore, rail surface damage influences rail internal defect formation. Altitude of the line is shown in Figure 11; and
- A higher proportion of track of 1500m radius and sharper curvature in the interior sections. These areas are subject to more eccentric loading, higher lateral loads and increased Rolling-Contact Fatigue (RCF).
